Buildings Survey Report

Architectural assessment

**Sonairte
Ninch
County Meath**

23 August 2021

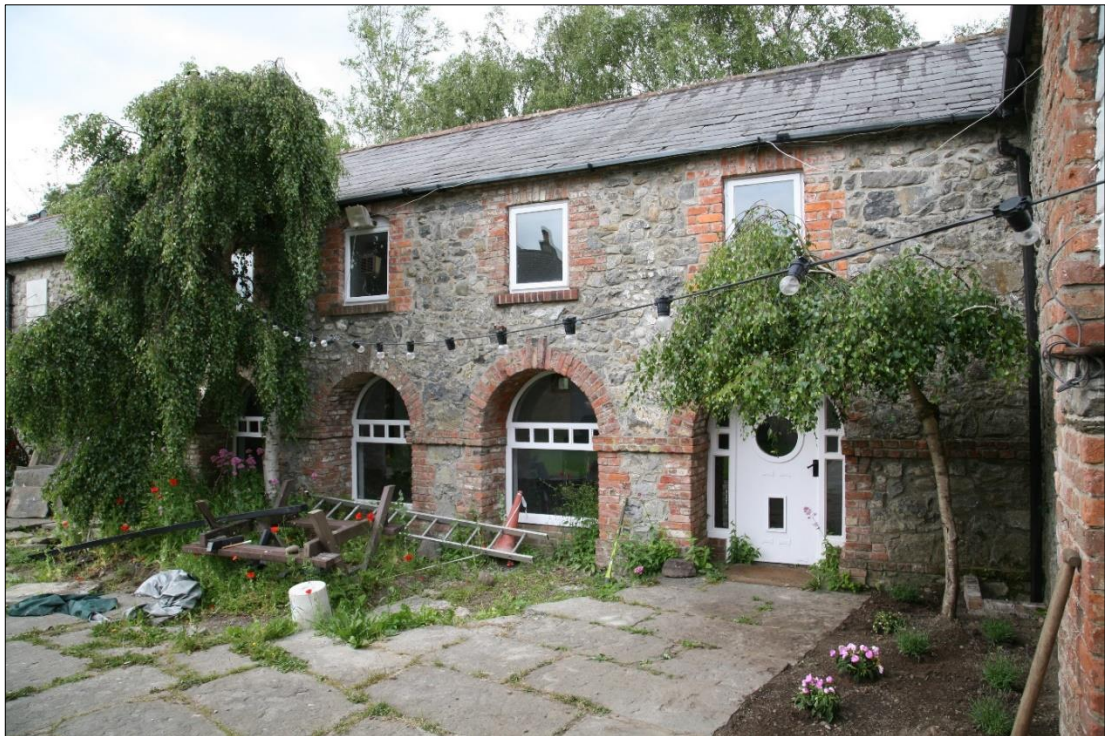
Plate 3

The five eastern bays of the northern range at ground floor level are arched openings into what were probably stables in the original scheme. New window opes have been inserted at first floor level which have been fitted with brick reveals (Plate 3). A modern, mostly glazed projection at the western end of the range obscures the domestic arrangement evident on Plate 1 (Plate 4). Here a primary chimney flue has been altered to serve a tall stack further down the roof slope, further interrupted by a glazed section. The masonry has been exposed to weathering by the removal of a protective lime-render.

Structure 1: eastern end of northern range

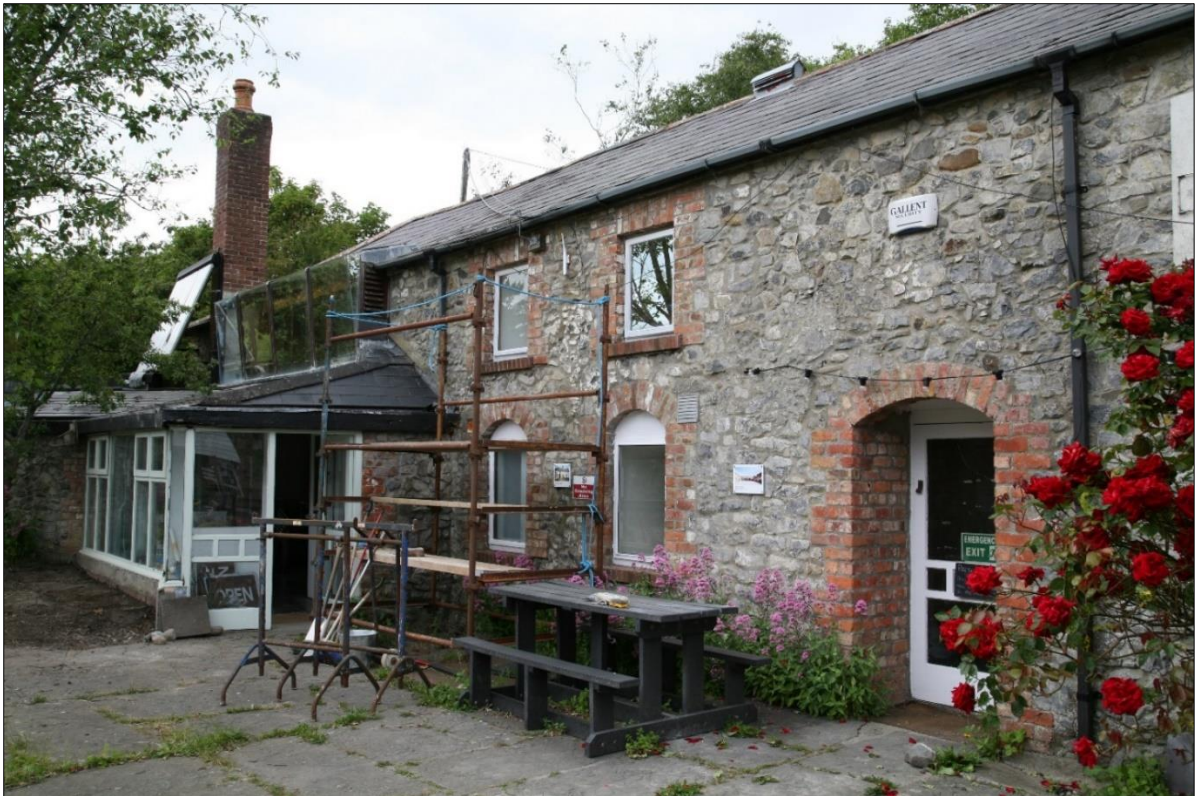
Plate 4 Structure 1: western end of northern range

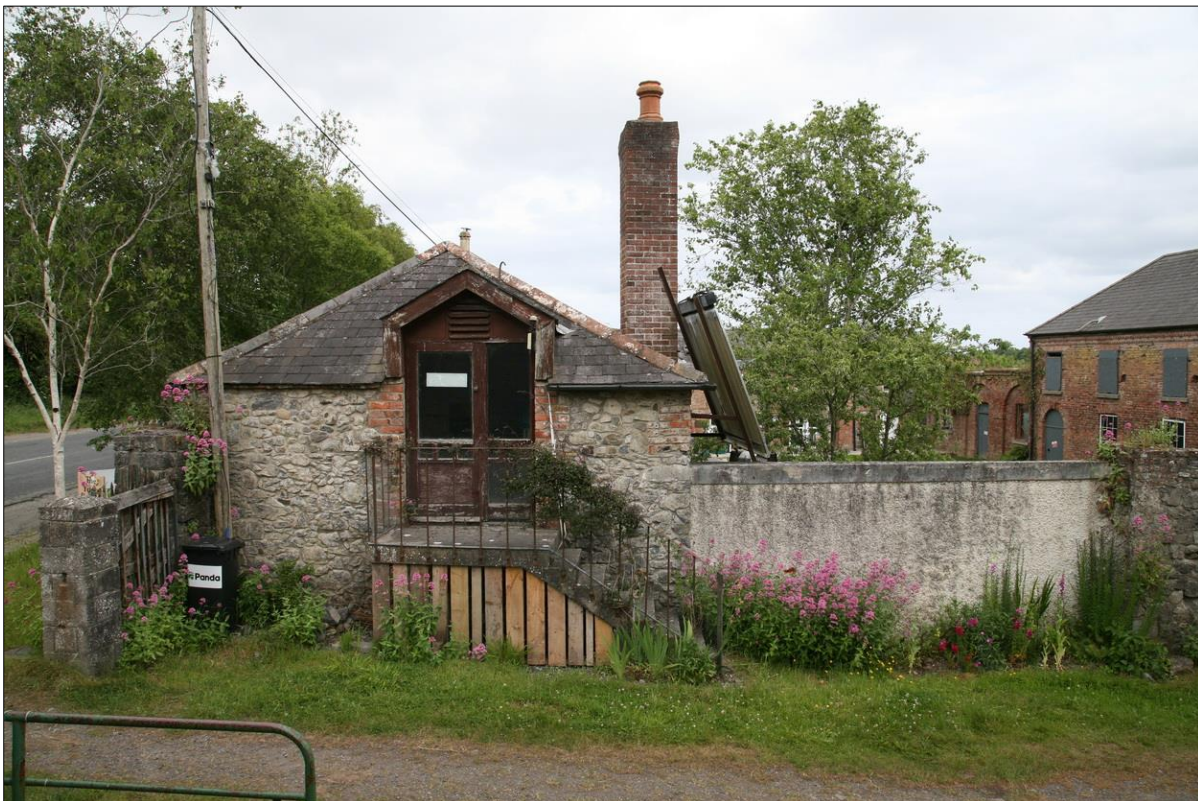
The northern elevation addressing the R150 is pebble-dashed and the small opes at ground floor level appear to be primary to the structure and may originally have served for ventilation. The western gable has an entrance broken through at first floor level, accessed by a concrete stair with a metal handrail (Plate 5).

Plate 5 Structure 1: western gable

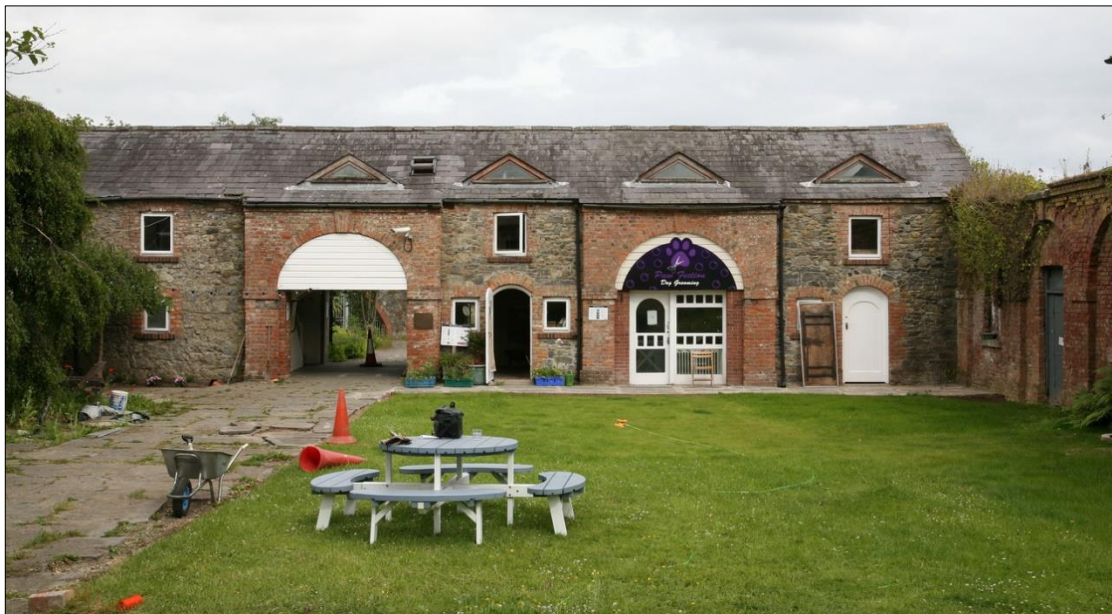
Plate 6

The eastern range is slightly grander in its conception, featuring a pair of large arched openings extending up both storeys and further expressed in slightly advanced brick sections (Plate 6). The brickwork may be an addition to the façade, undertaken with the construction of Structure 5, the southern range. The first floor is lit on both sides of the roof by modern triangular lights and accommodates several small, interconnected spaces.

Both ranges of Structure 1 appear to be in good repair, although the absence of a protective lime-based render to the elevations is regrettable. The interventions undertaken at the western end of the northern range are not particularly sympathetic to the historic fabric, however they constitute an element of the *Sonairte's* built history and are thus part of the narrative of the site.

Structure 1: eastern range

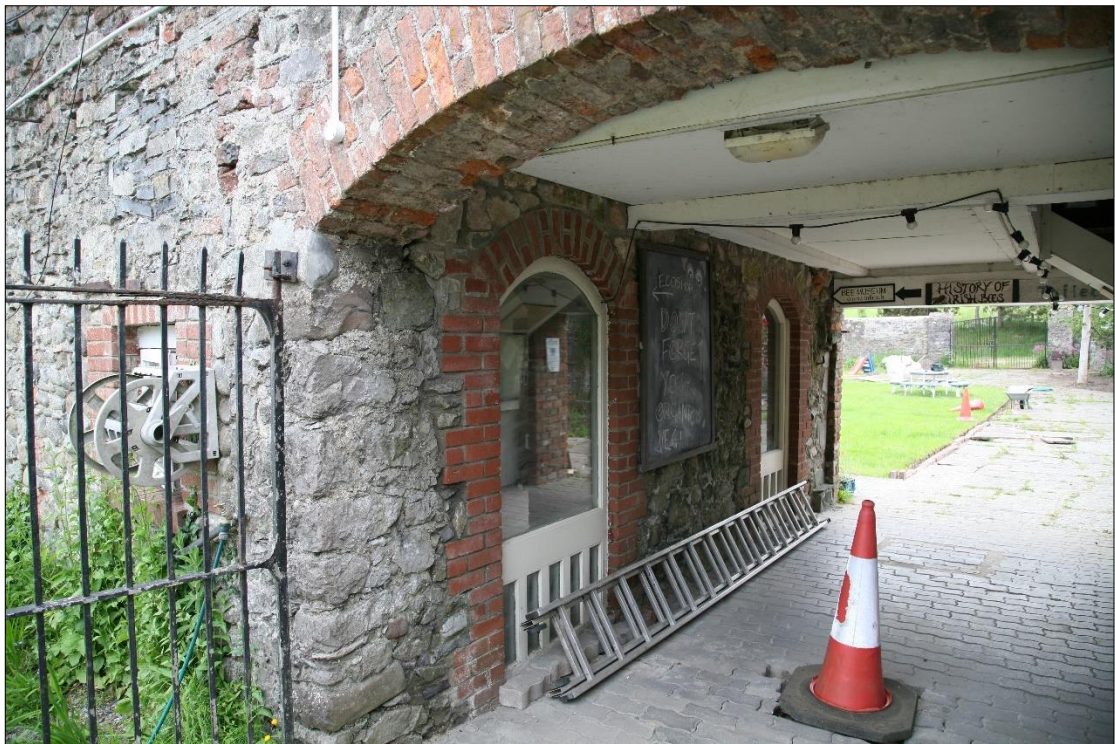
New arched openings with modern brick reveals have been broken through under the entrance arch accessing the farmyard to the east (Plate 7), the upper portion of which has been closed off in timber sheeting, with an inserted floor level behind. Where the opposite arch is lower and accommodates the floor level, this may further suggest alterations to the western elevation.

Plate 7 Structure 1: arch reveal in masonry and interior interventions in modern brick

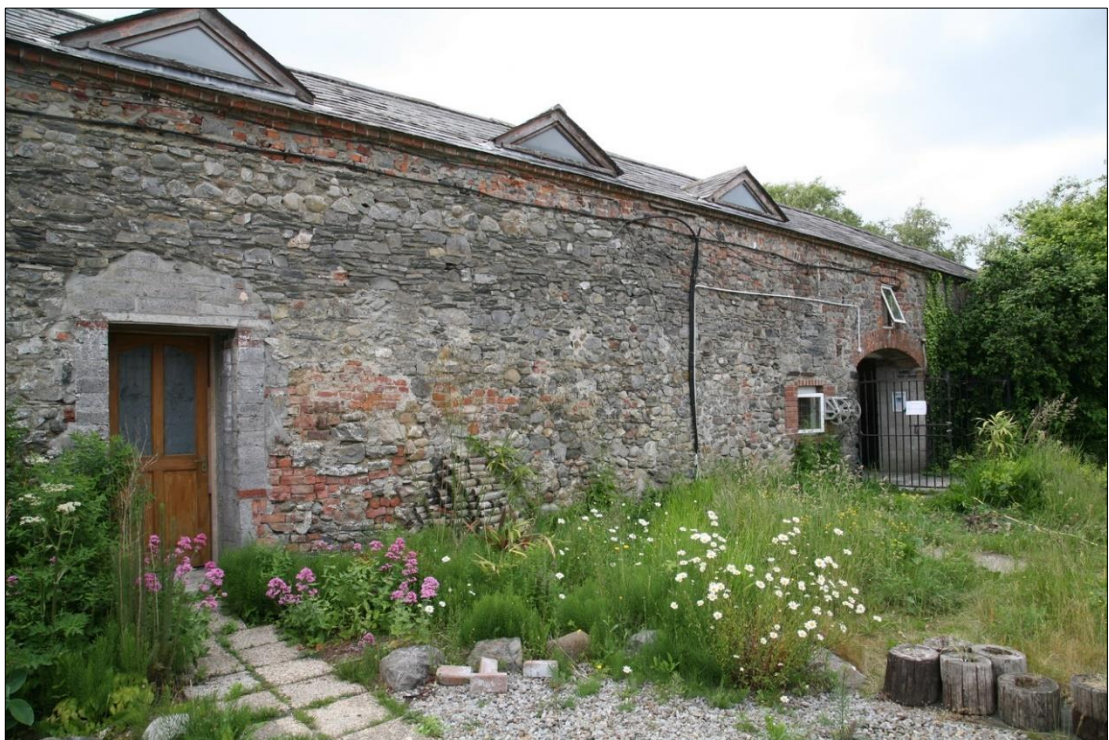
The rear elevation demonstrates modern openings and perhaps older repairs (Plate 8). The now-removed western range of the west courtyard was built against the back wall, which continues to the south in the same build beyond the southern gable. Where the eastern gable of Structure 5 falls short of this wall, there is a strong suggestion here of a primary southern range, which was removed prior to the construction of Structure 5. This is discussed further below.

Plate 8 Structure 1: eastern elevation of eastern range

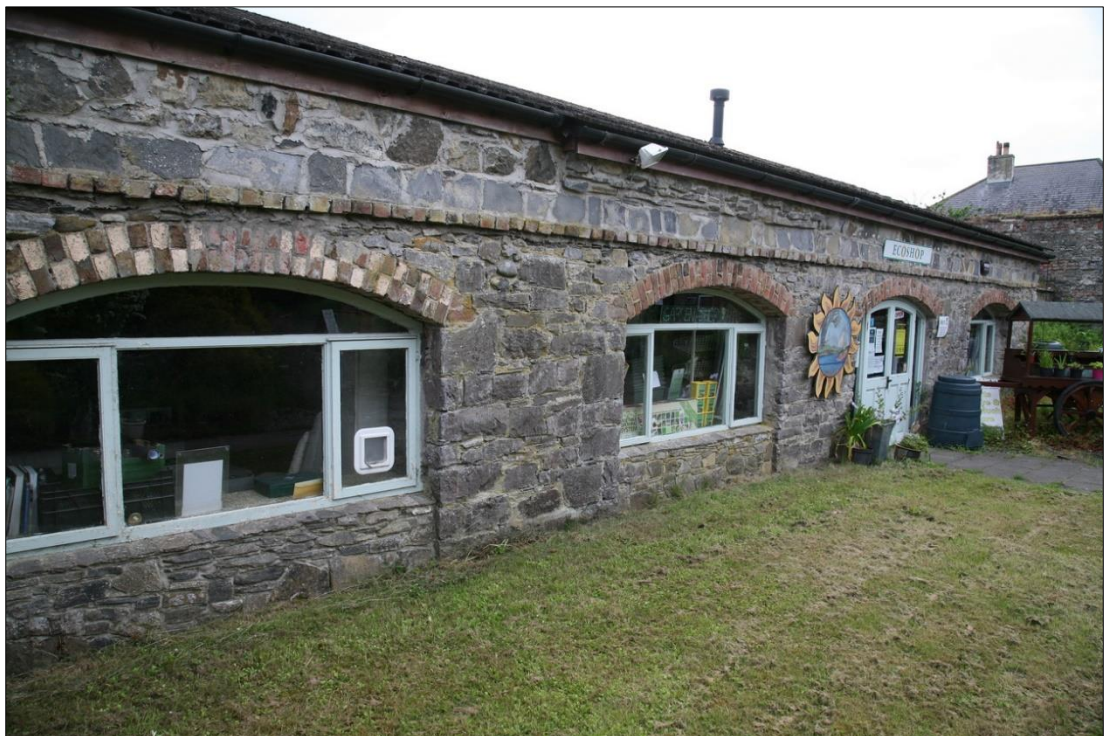
Structure 2 comprises the southern range of the eastern courtyard and accommodates a shop. With four low, wide arched opes occupying most of the façade, it is possible the building was constructed as an open arcade and it certainly extended in some form westwards where it was built against the southern end of Structure 1. It is in any event better built than the other masonry structures on site, using larger and better coursed masonry. It is quite likely that the building was protected by a lime-based render, although no trace of this survives. The brick in the reveals is of better quality than seen elsewhere, but is possibly a secondary insertion.

Structure 2 was not accessed but does not appear to have any significant structural issues on external inspection.

Plate 9 Structure 2: detail of arcade

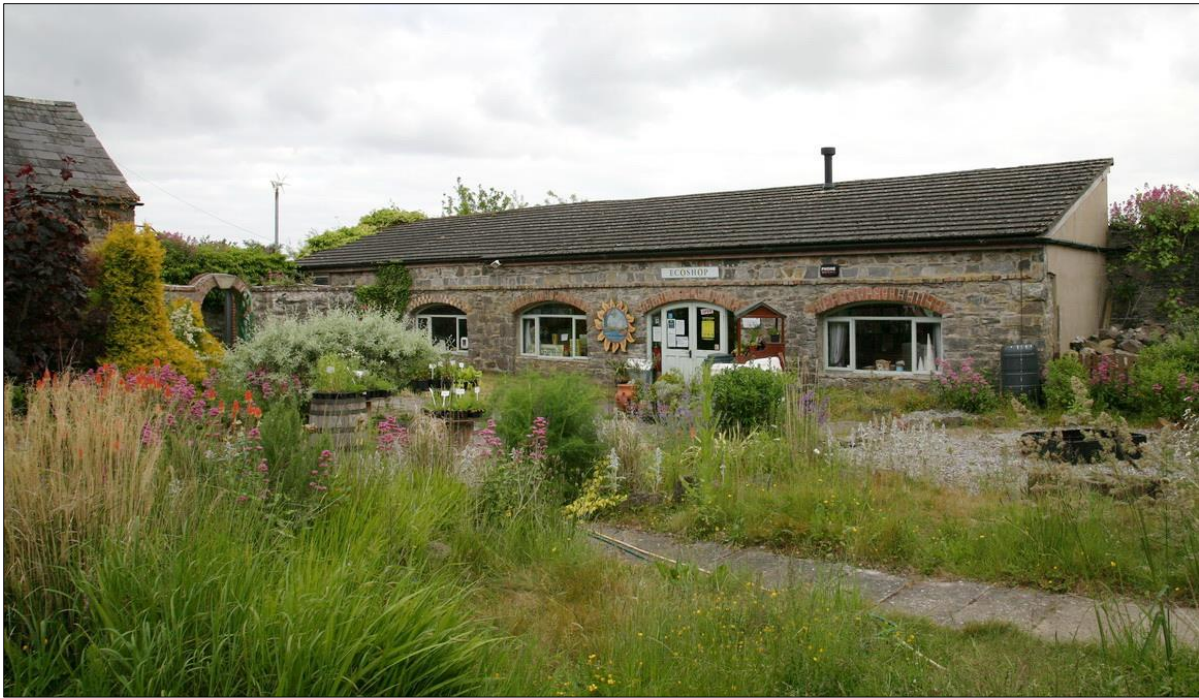
The roof profile has undergone a significant alteration, where it now has a modern single-pitch to the front with cement-fibre tiles. Where the eaves course appears to have been rebuilt over a brick stringcourse, it is possible that first floor accommodation was provided above.

Plate 10 Structure 2: general view of north elevation, with Structure 3 (left)

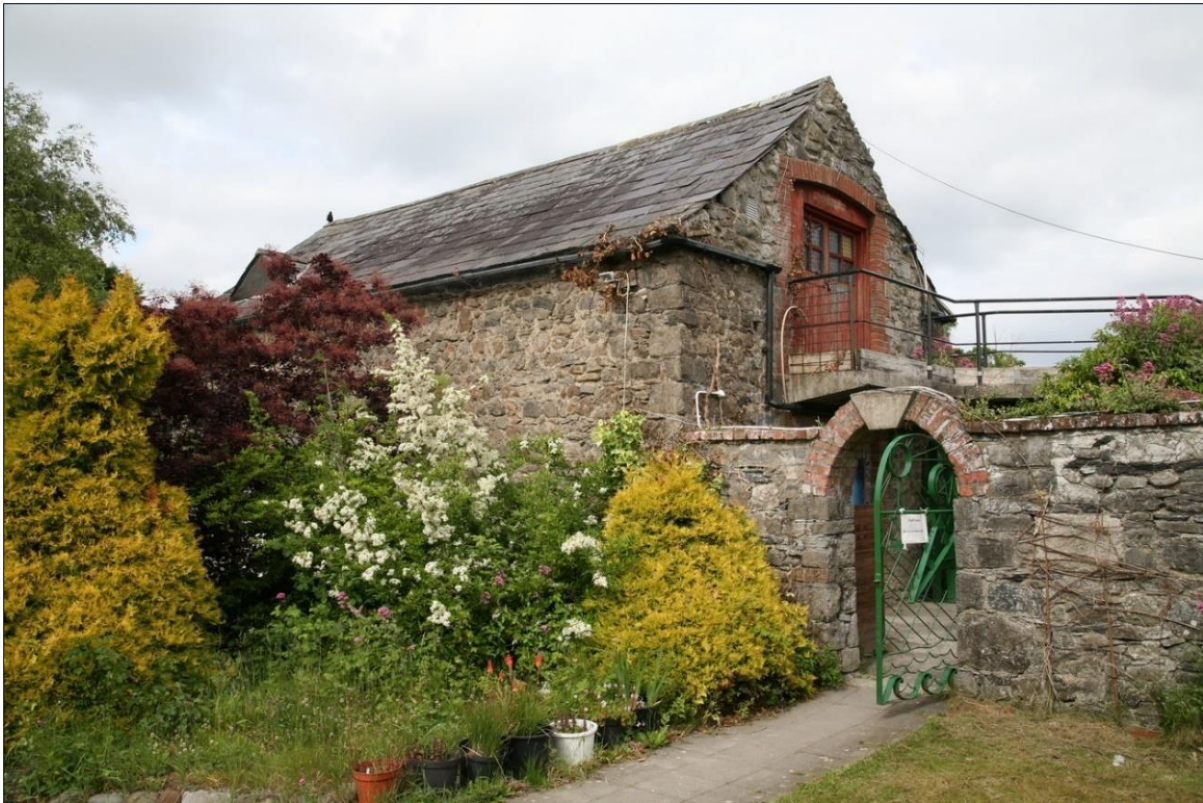
Where the Barn is a two-storey structure with a gabled pitched roof, the remainder of the range appears on Plate 12 to have been single storey and was keyed into Structure 2 forming the southern range. A wall extending south is a remnant of this structure and a primary ope has been fitted with a brick arch (Plate 13).

Structure 3 appears from the exterior to be in good condition, although its protective render has been removed, exposing the rubble masonry construction. It is recommended below that the elevations be rendered with a lime-based material, after small areas of cement repair have been raked out and the structure as a whole repointed.

Plate 13 Structure 3 from the southwest

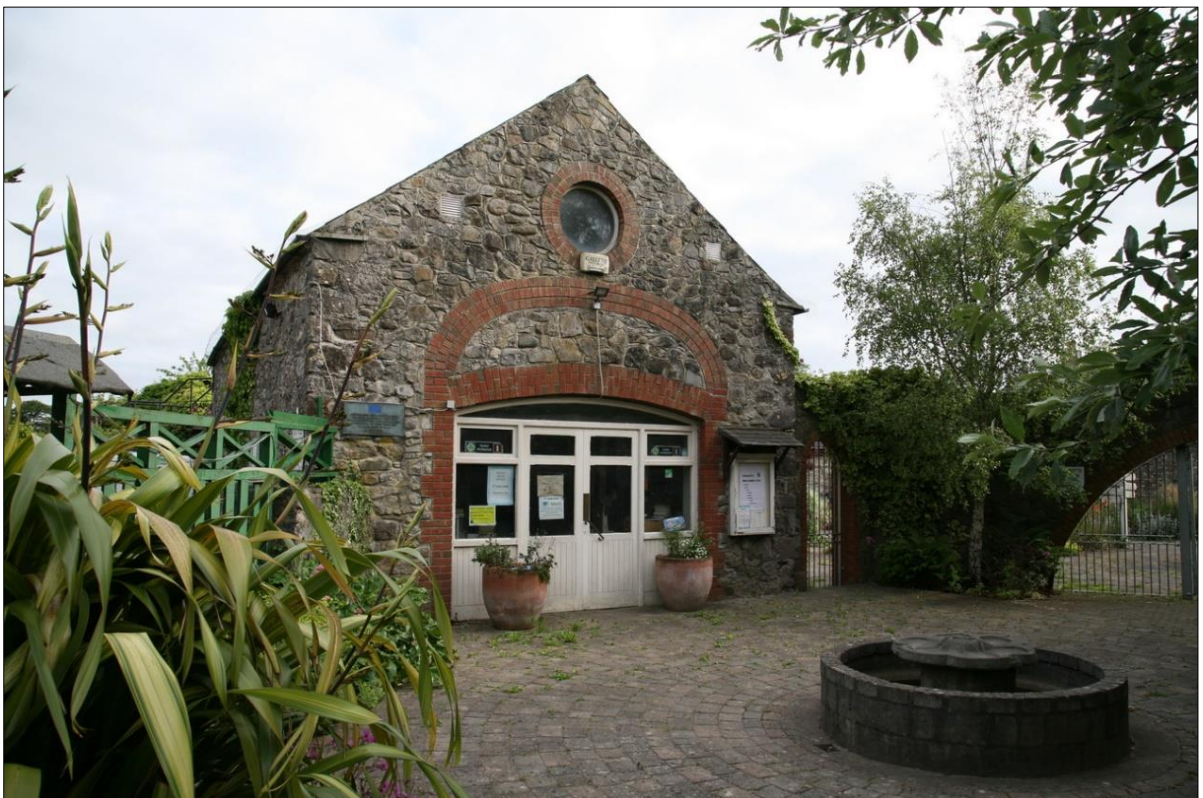
The building functions as a ticket office and information centre and is the first structure encountered by the public as they enter *Sonairte*. The northern gable, through which the ticket office is accessed, has had its brick elements replaced with modern 'distressed' brick, where the uncoursed rubble masonry has been heavily reported in a cement-based mortar (Plate 14). The southern elevation has also seen two double entrances broken through with modern brick reveals. The first floor entrance is accessed by a cast concrete walkway with metal handrails (Plate 15).

Plate 14 Structure 3: northern elevation

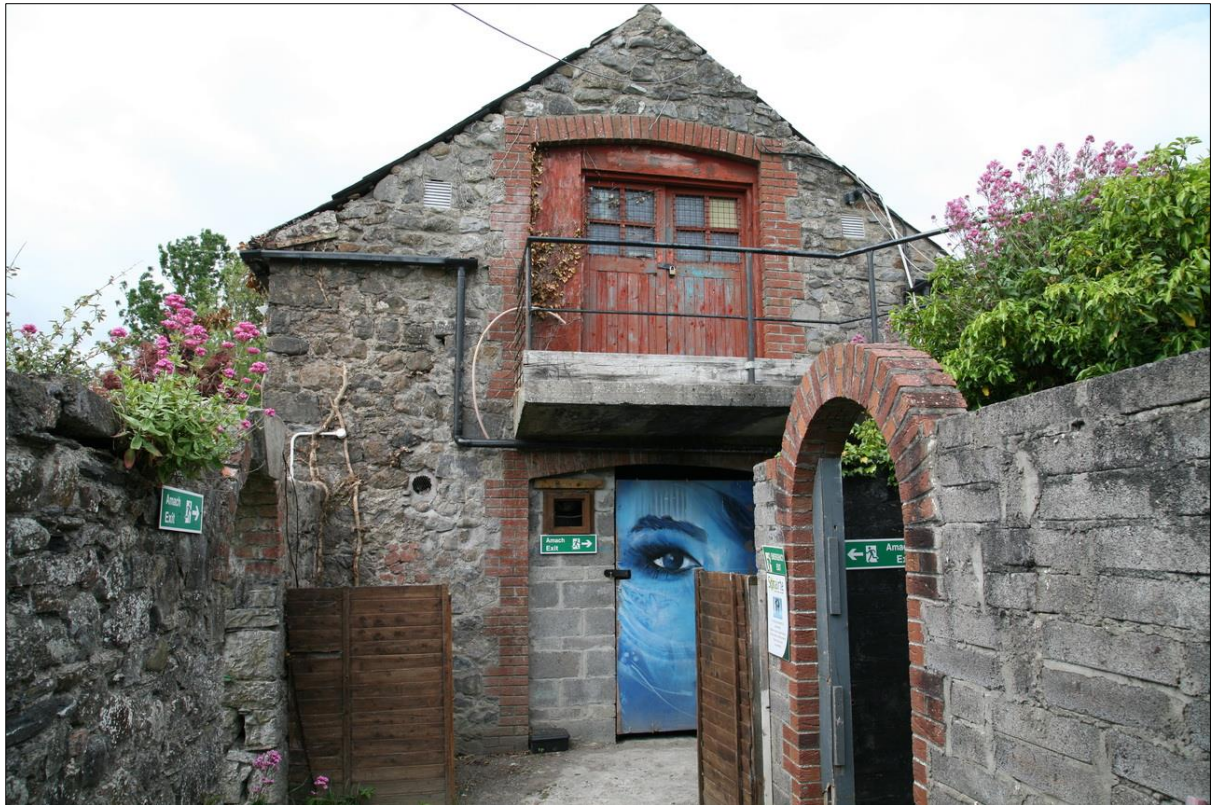
Plate 15 Structure 3: southern elevation

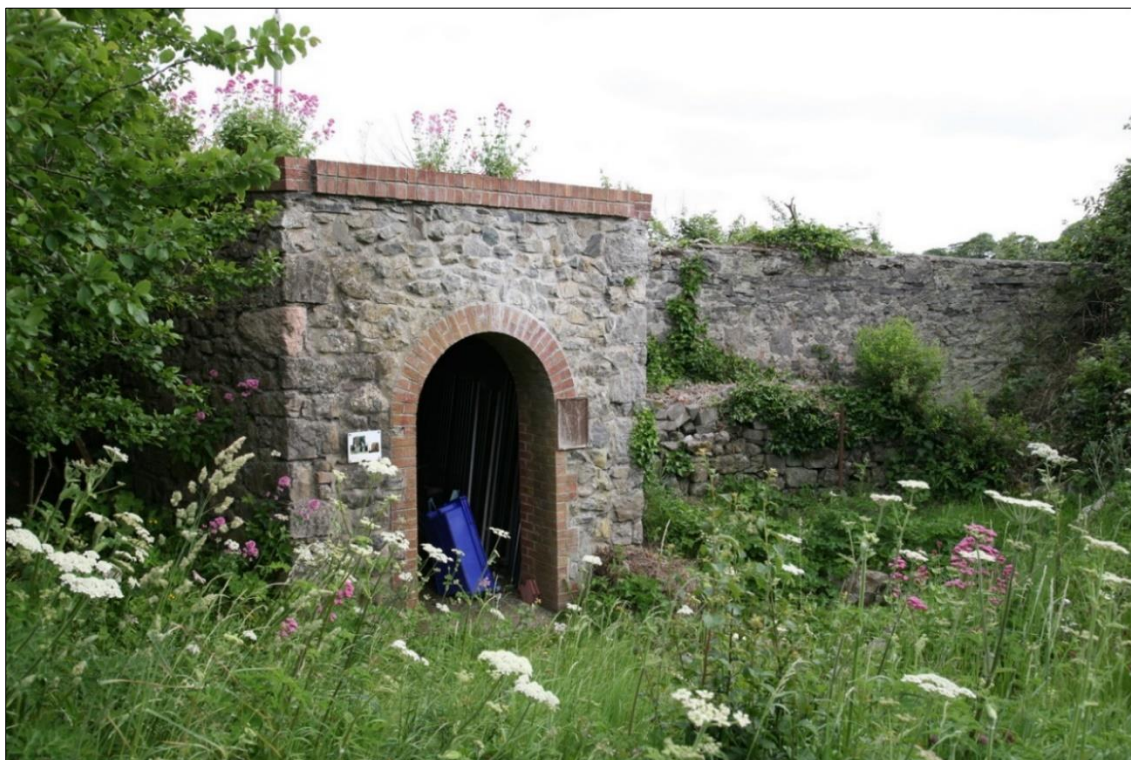
Plates 16 and 17 show a structure perhaps three times as tall as the truncated remnant, with brick courses rising above the masonry foundation featuring large recessed arches to the two visible elevations with a projecting string course at the springer level and brick keys. Where there is evidence for a render in the arched recesses and over the masonry below, it is unclear as to whether the entire structure was originally rendered. In its truncated form, the original entrance has been rebuilt in modern brick incorporating an arch, where the masonry courses above are capped, also in modern brick (Plate 18).

The tower has been reduced to its rubble masonry at ground floor level, with two capping courses in modern brick affixed with cement. The arched entrance has modern brick reveals and possibly retains a structural function. Ivy has started to take root and will quickly extend across the structure unless checked.

Plate 18 Structure 4

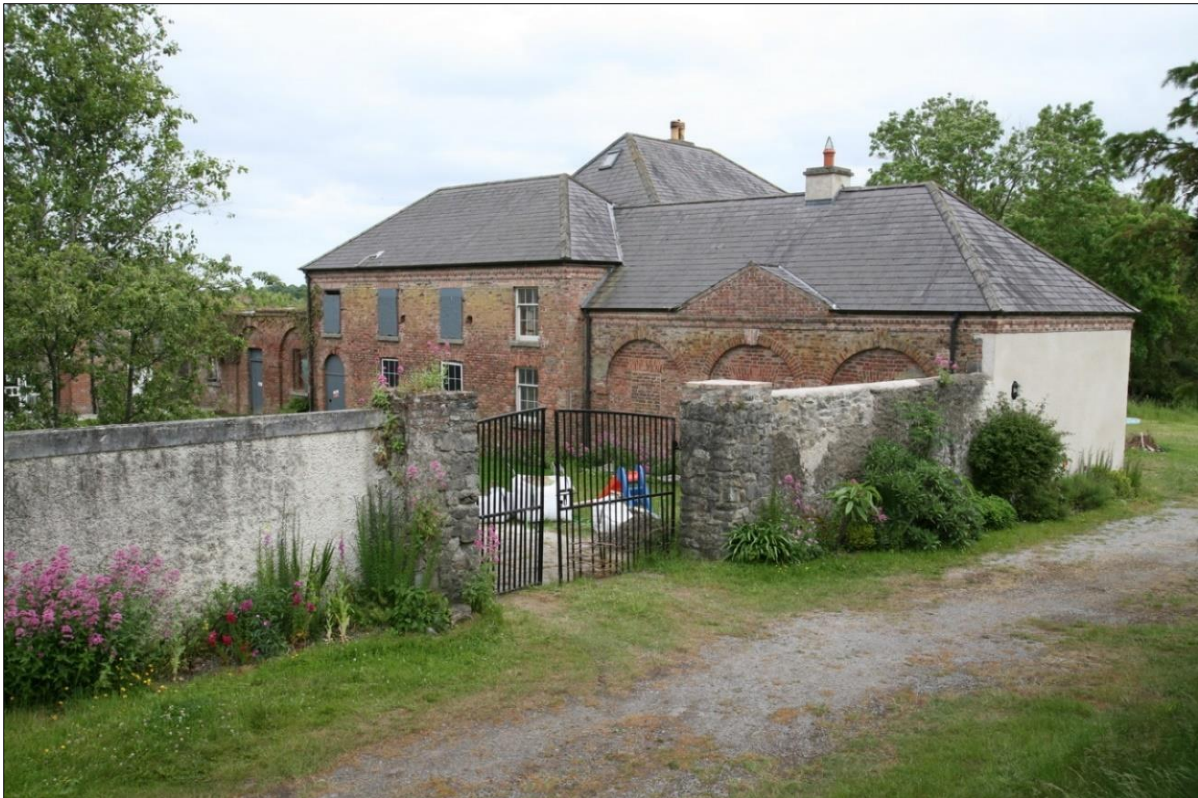
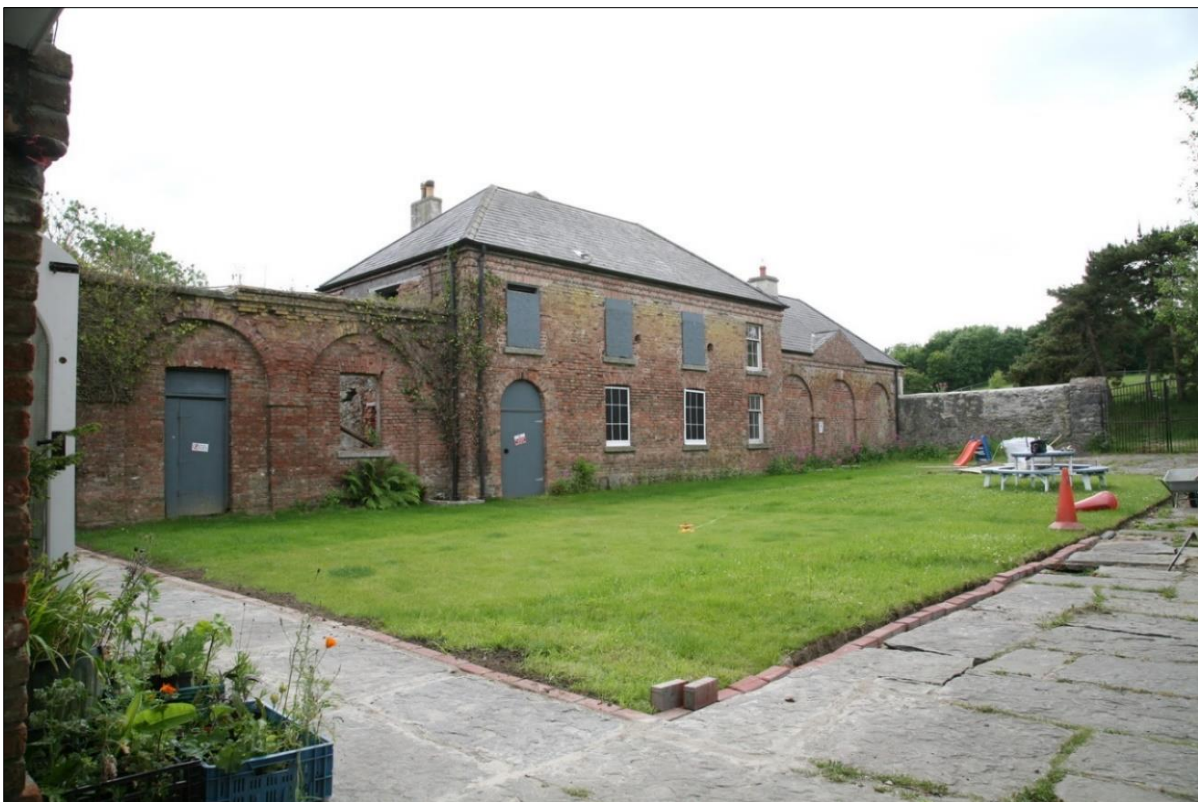
The southern range of the East Courtyard, an elevation now expressed in a patchy dark red brick with failing mortar joints, is perhaps the most attractive, if not the most intriguing of all the structures in the assemblage (Plates 19 and 20). Its proportions suggest the hand of an architect in its design, one working in the middle third of the eighteenth century when Palladianism was emergent in grander commissions. The elevation to the farmyard comprises a central two storey, four bay block, advanced between three-bay pedimented wings. The western and central sections have been reroofed in recent years, where the former was probably incorporated into the house c. 1864. The east wing has little surviving behind its façade and has lost its pediment.

The surviving brickwork throughout is in poor condition, with a different brick type used in the upper courses of the central section. This suggests the building was undertaken on a shoestring, initially in a bad-quality brick. Over perhaps 70% of the elevation the brick face has weathered, and the mortar joints have eroded back, although there is little to suggest that the structure is off-plumb or in danger of catastrophic failure.

Plate 19 Northern elevation of Structure 5 and gated entrance to farmyard

Plate 20 Structure 5: northern elevation

In any event, it is recommended below that the structure be inspected by a conservation engineer, to generate a document which will inform any further conservation measures to be undertaken.

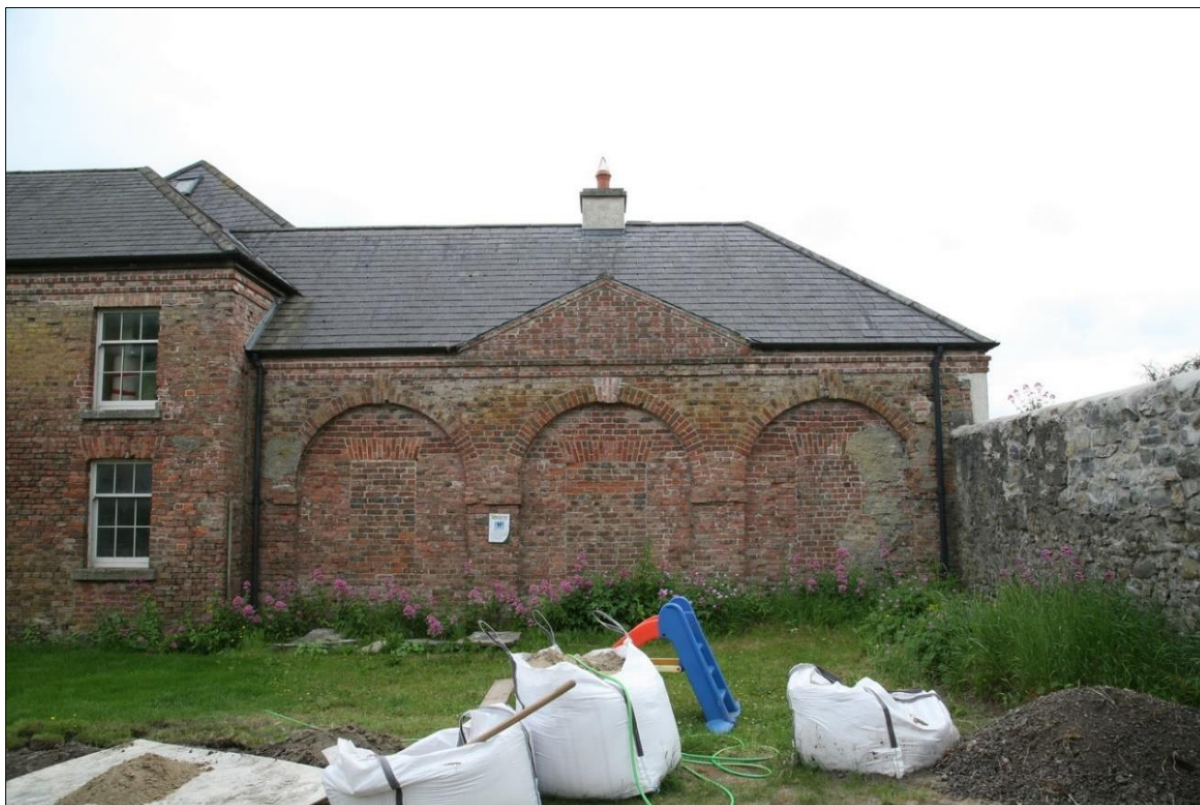
Plate 21 Structure 5: northern elevation of west wing

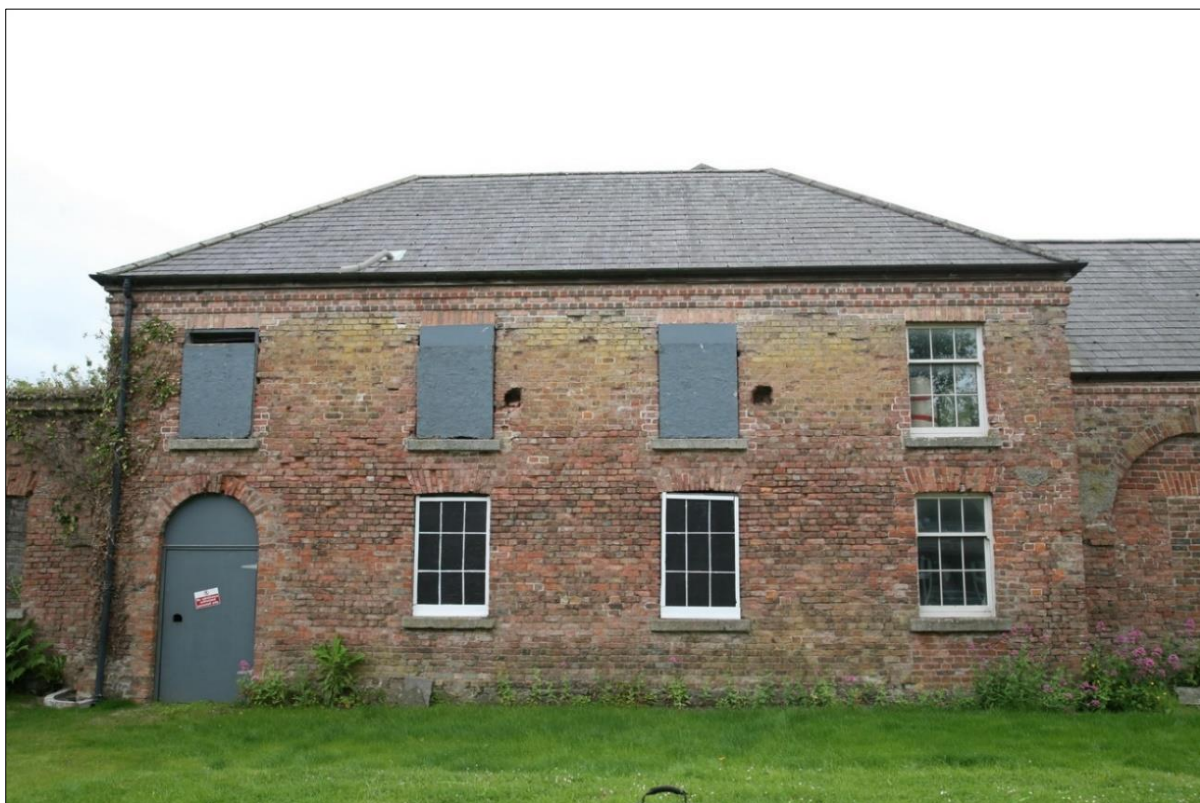
Plate 22 Structure 5: northern elevation of central block

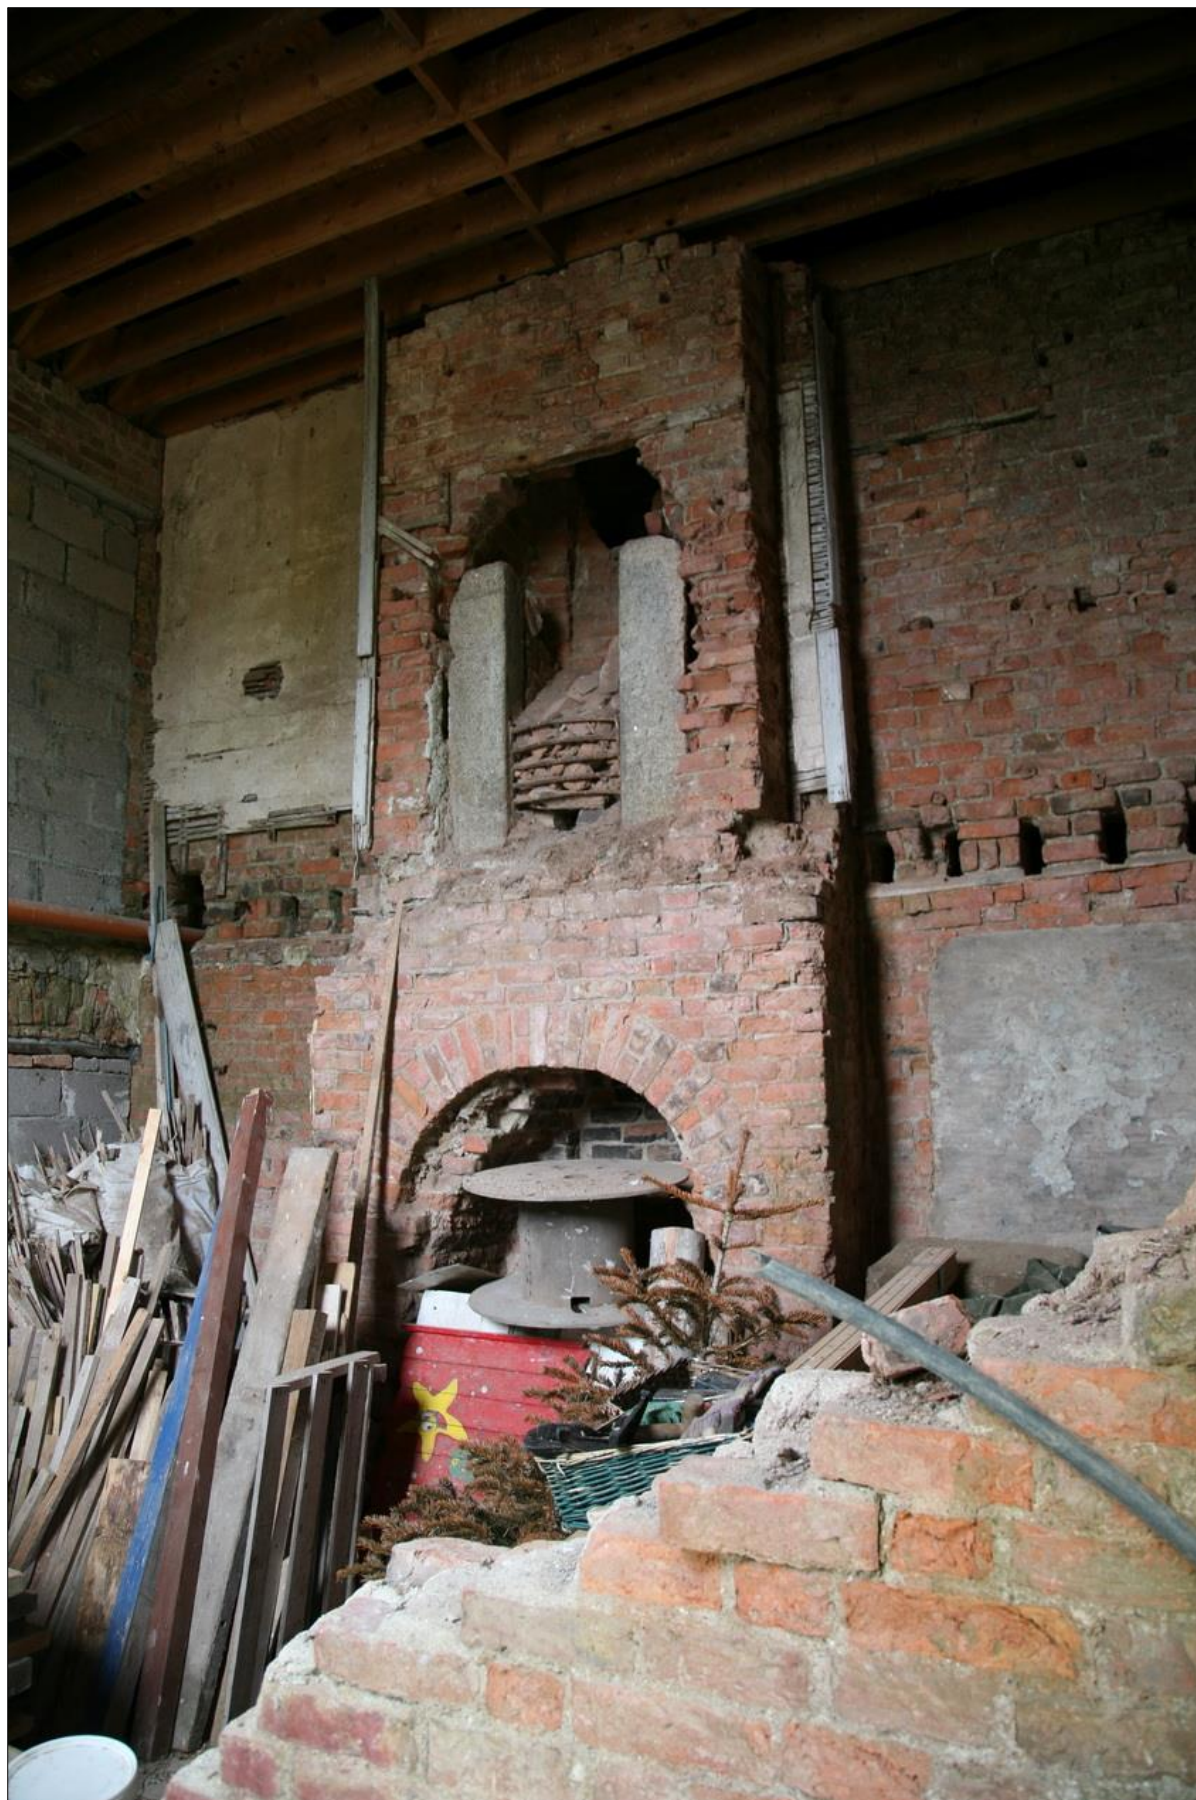
Plate 23

Structure 5: eastern elevation of party wall in central block

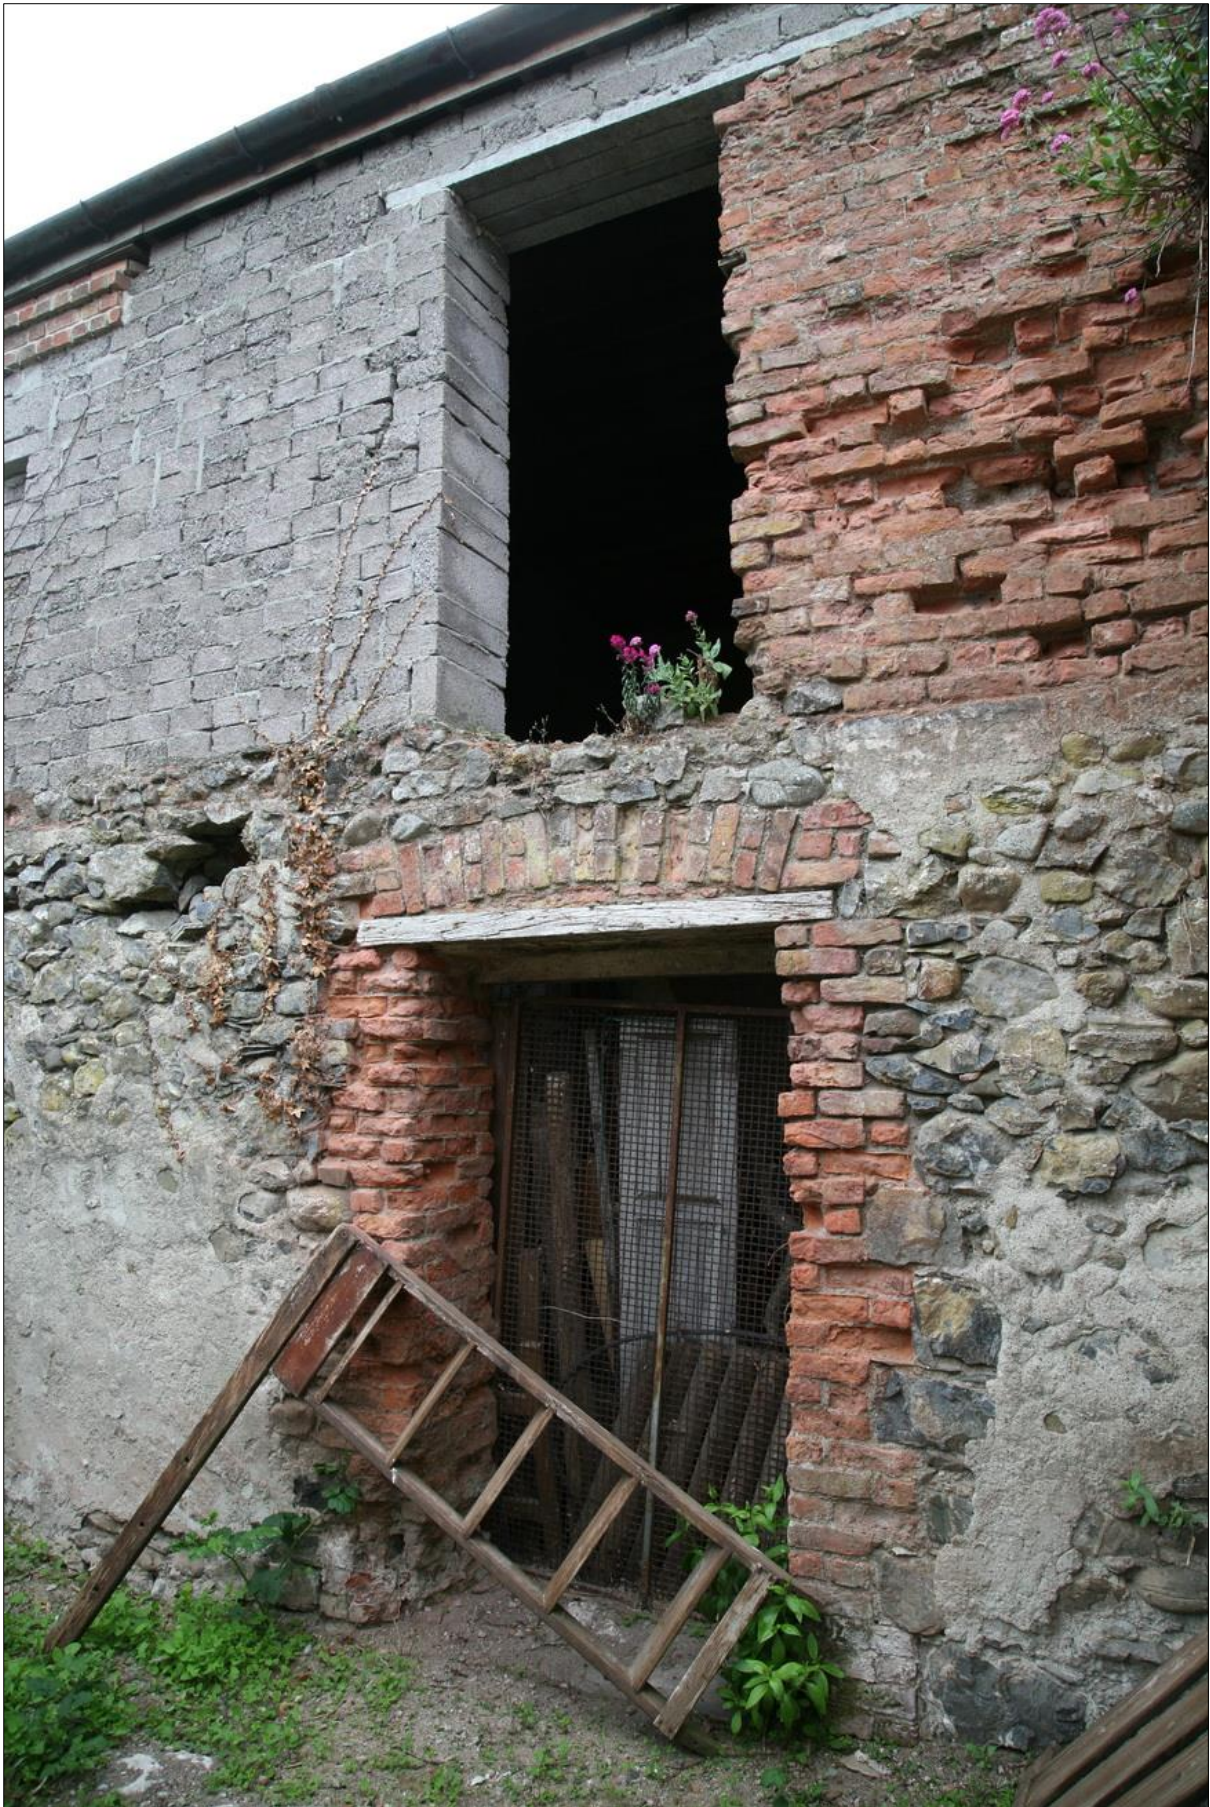
Plate 24

Structure 5: eastern wall of central block with surviving ope accessing east wing

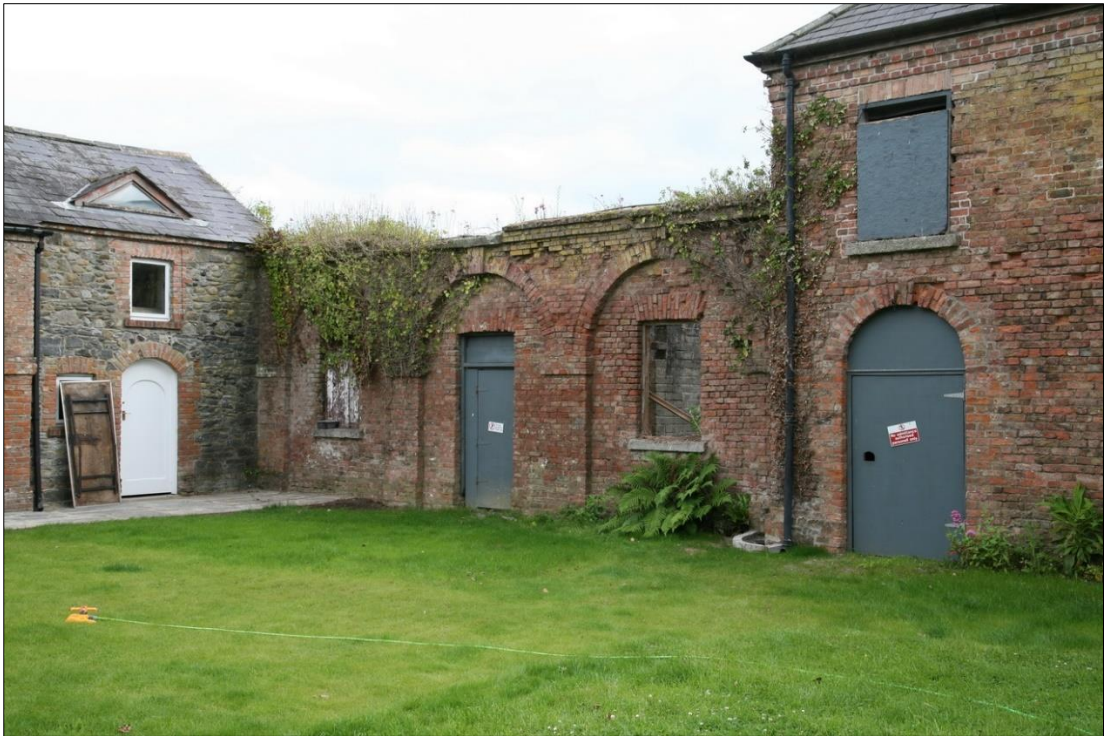
Plate 25

In a structural sense, the east elevation and elements of the south elevations have been rebuilt in blockwork, presumably when the structure above was being re-roofed. The two eastern bays can be considered derelict where the first floor and staircase are missing, along with the west wall of the passage running through, which may have been vaulted.

Structure 5: northern elevation of east wing

One immediate recommendation which will not require planning permission concerns the removal of the free-standing blockwork walls within the roofless footprint, where it may be possible to turn the space to a temporary outdoor public use, pending its conservation. It is not however recommended that the east wing be rebuilt, where there is scope to incorporate a contemporary structure behind the conserved brick façade.
