Buildings Survey Report

Architectural assessment

**Sonairte
Ninch
County Meath**

23 August 2021

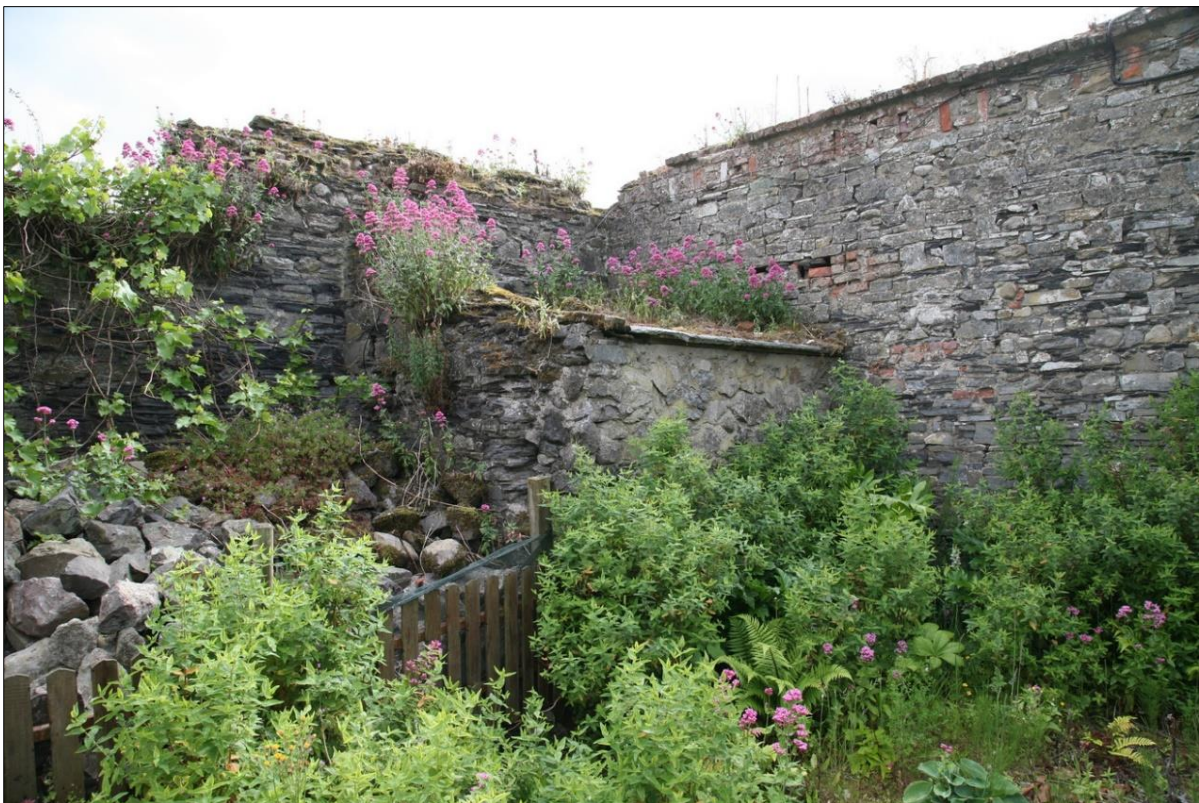
Plate 11 Remnant structure against eastern wall of

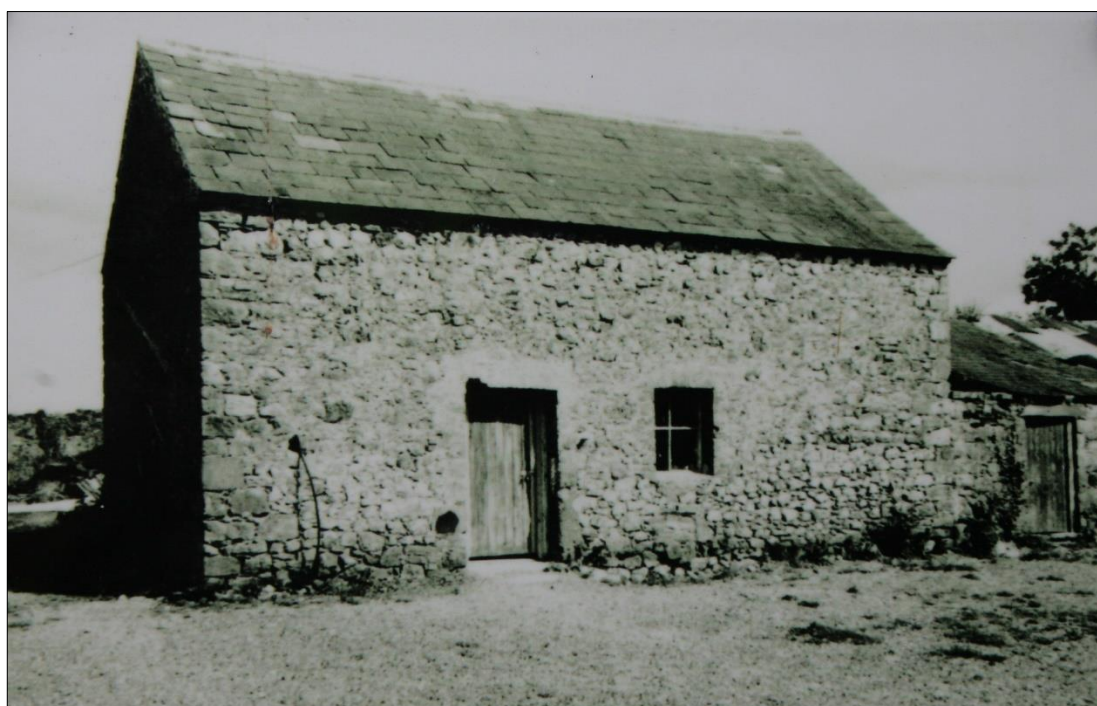
Where the Barn is a two-storey structure with a gabled pitched roof, the remainder of the range appears on Plate 12 to have been single storey and was keyed into Structure 2 forming the southern range. A wall extending south is a remnant of this structure and a primary ope has been fitted with a brick arch (Plate 13).

Structure 3 appears from the exterior to be in good condition, although its protective render has been removed, exposing the rubble masonry construction. It is recommended below that the elevations be rendered with a lime-based material, after small areas of cement repair have been raked out and the structure as a whole repointed.

Plate 12 Structure 3, *The Barn*, western elevation, n.d.

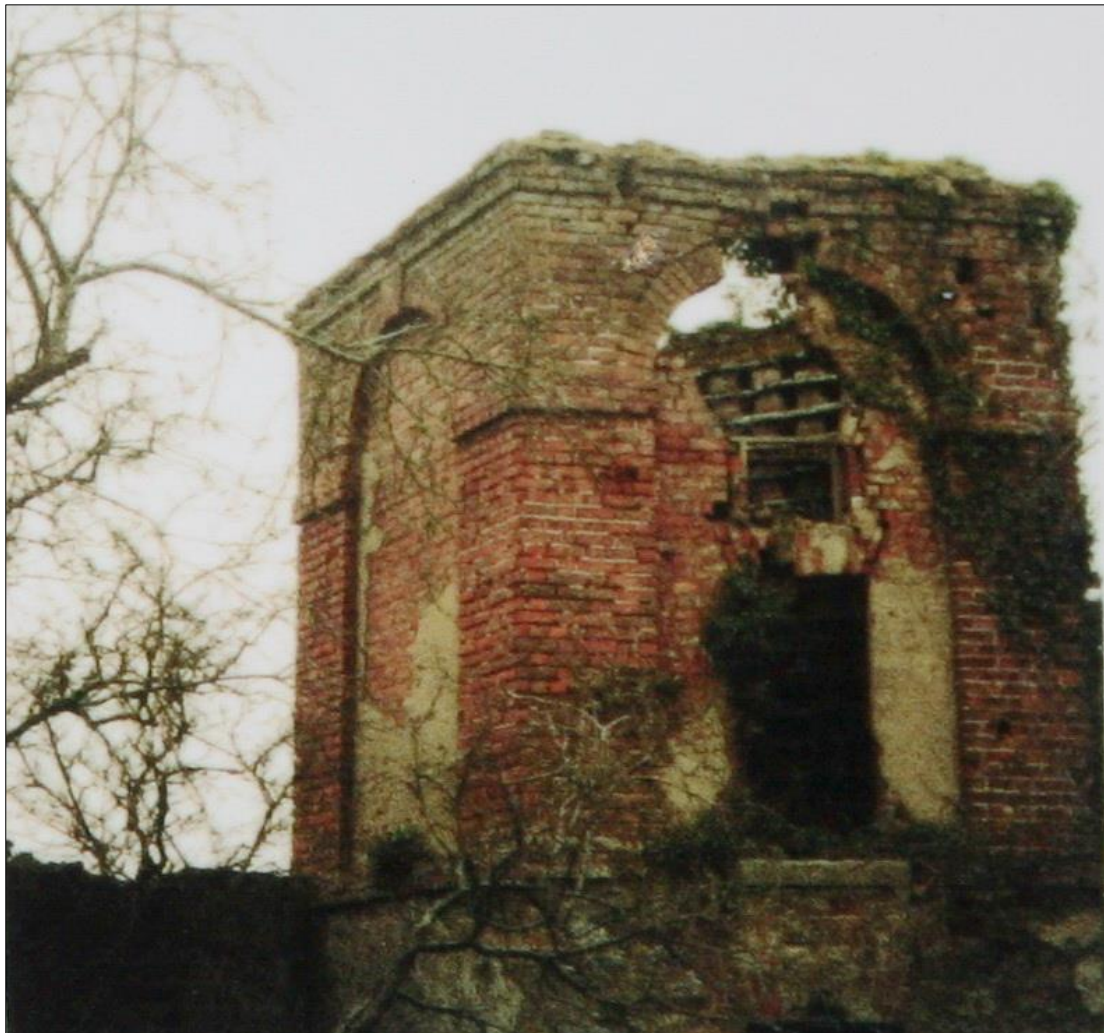
Plate 16

Plates 16 and 17 show a structure perhaps three times as tall as the truncated remnant, with brick courses rising above the masonry foundation featuring large recessed arches to the two visible elevations with a projecting string course at the springer level and brick keys. Where there is evidence for a render in the arched recesses and over the masonry below, it is unclear as to whether the entire structure was originally rendered. In its truncated form, the original entrance has been rebuilt in modern brick incorporating an arch, where the masonry courses above are capped, also in modern brick (Plate 18).

The tower has been reduced to its rubble masonry at ground floor level, with two capping courses in modern brick affixed with cement. The arched entrance has modern brick reveals and possibly retains a structural function. Ivy has started to take root and will quickly extend across the structure unless checked.

Structure 4, n.d.

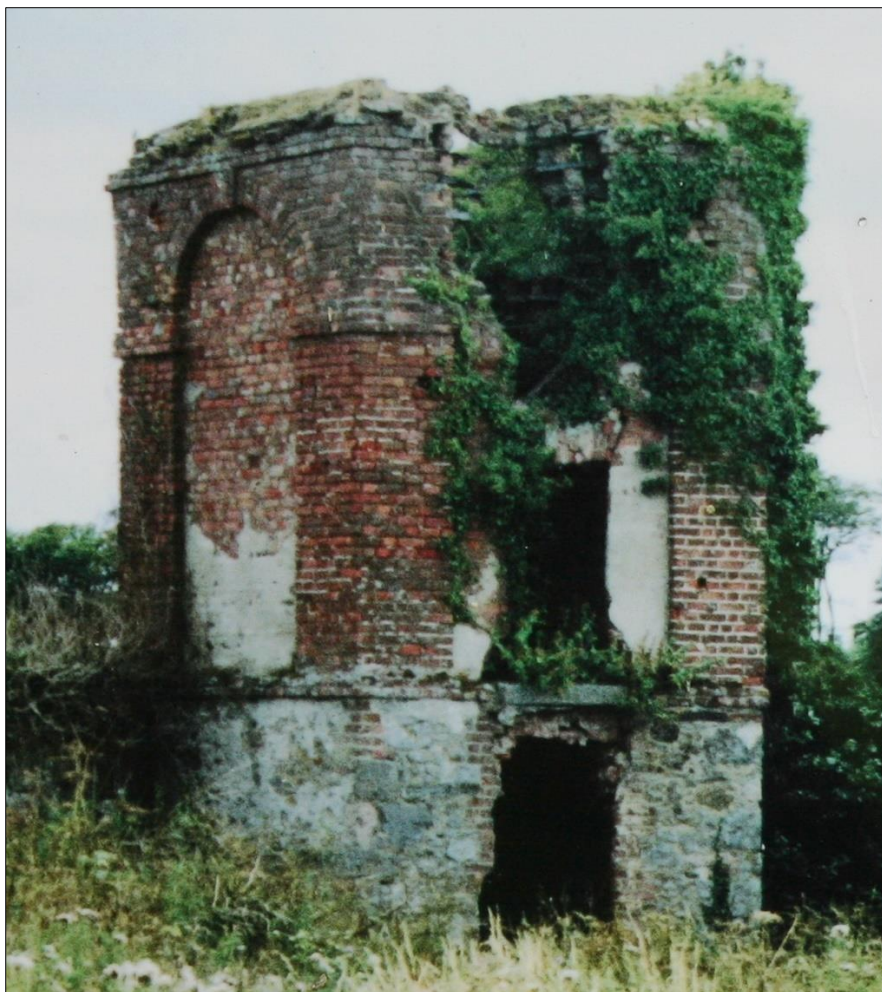
Plate 17 Structure 4, n.d.

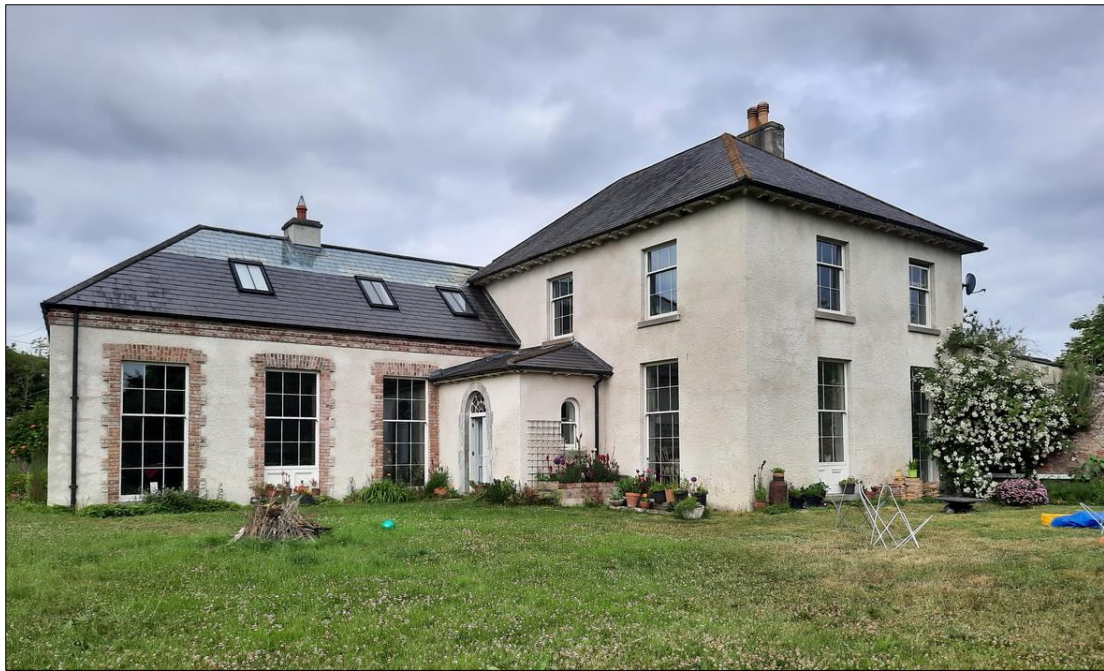
Ninch West has undergone sympathetic external work which has limewashed the walls, exposing the brick reveals in the southern elevation of the western section of Structure 5 (Plate 26). The fenestration has been especially well considered, where the overall effect suggests a house perhaps 100 years earlier than the present c. 1865 iteration. The original house would appear to survive in the porch and Gibbsian doorcase.

Plate 26 *Ninch West*, with southern elevation of the western section of Structure 5 (left)
